COMMERCIAL WINDSTORM MITIGATION REPORT (OIR-B1-1802)

Sun Ketch I Condominium Association, Inc.

200-204 Bounty Ct

FPAT File# MUD1914038

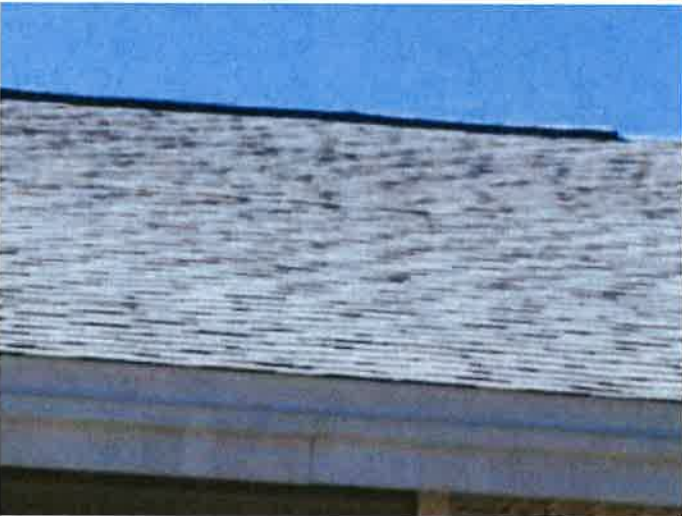
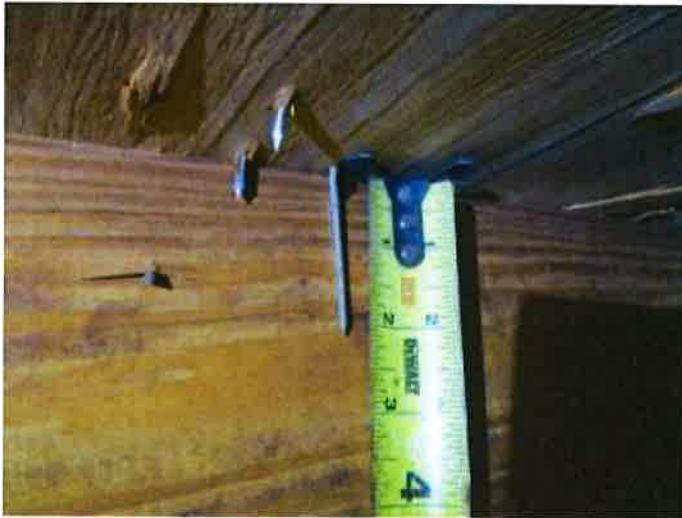
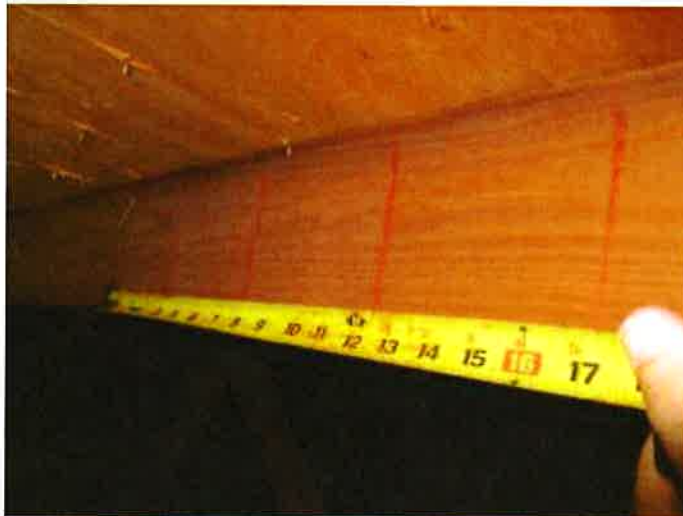
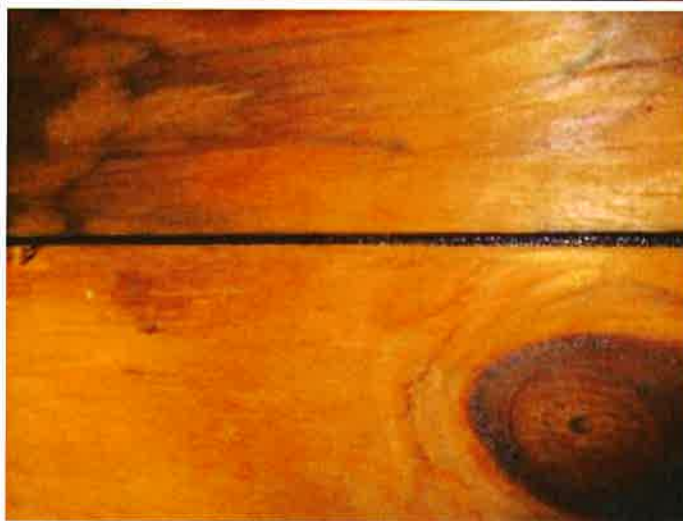
Roof Construction

3. **Roof Deck Attachment:** **Level C**
Comments: Inspection verified 1/2" plywood and OSB roof deck attached with 8d nails at a minimum 6" on the edge & 6" in the field.

4. **Roof to Wall Attachment:** **Clips**
Comments: Inspection verified hurricane clips fastened with a minimum of three nails.

6. **SWR:** **Yes**
Comments: SWR was verified at time of inspection. The Secondary Water Resistance verified is a self-adhering peel and stick.

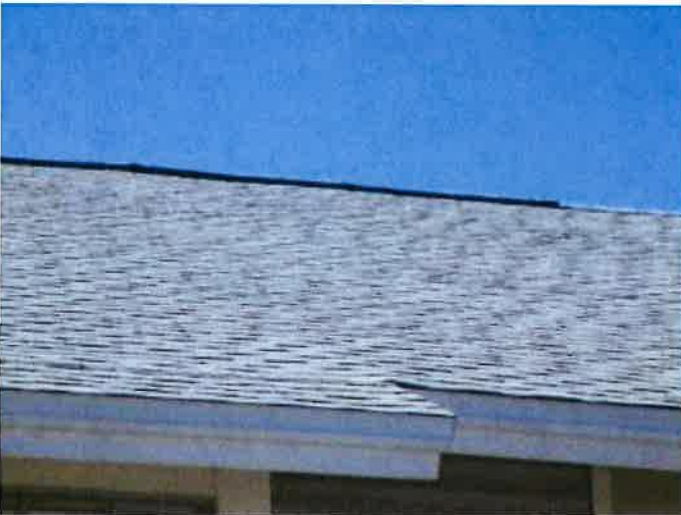
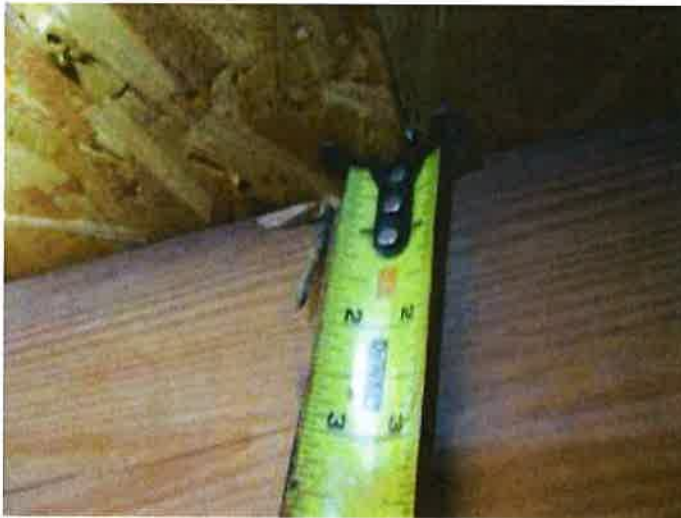
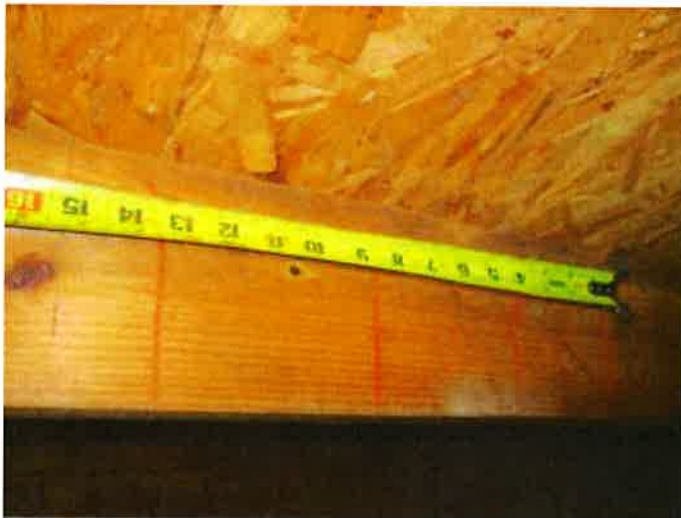
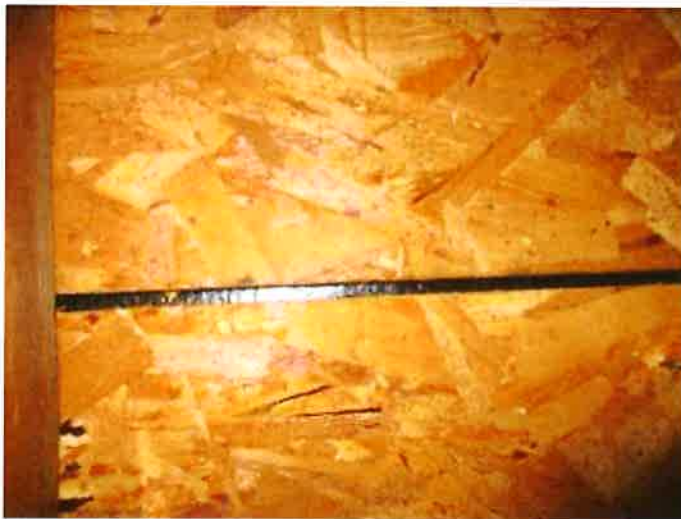
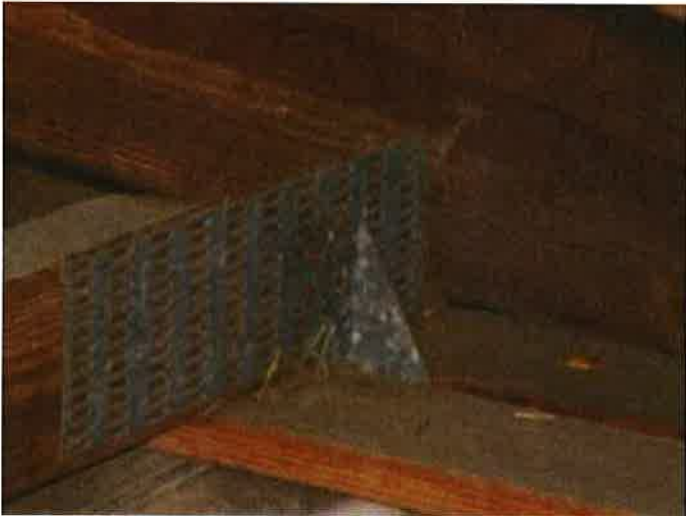
Roof Construction

3. **Roof Deck Attachment:** **Level C**
Comments: Inspection verified 1/2" plywood and OSB roof deck attached with 8d nails at a minimum 6" on the edge & 6" in the field.

4. **Roof to Wall Attachment:** **Clips**
Comments: Inspection verified hurricane clips fastened with a minimum of three nails.

6. **SWR:** **Yes**
Comments: SWR was verified at time of inspection. The Secondary Water Resistance verified is a self-adhering peel and stick.

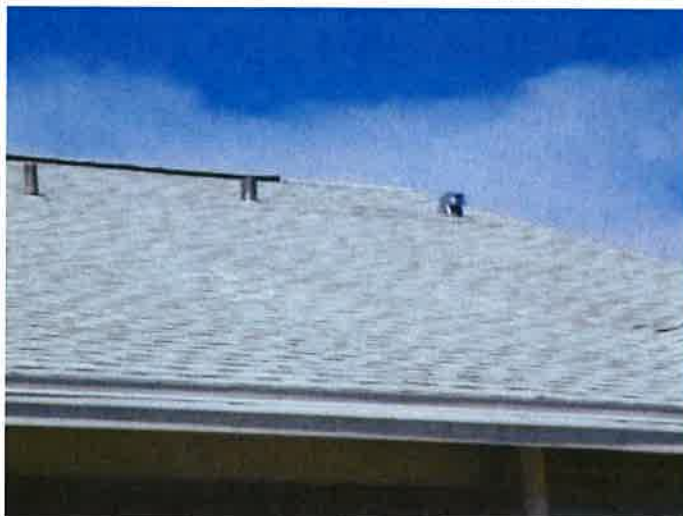
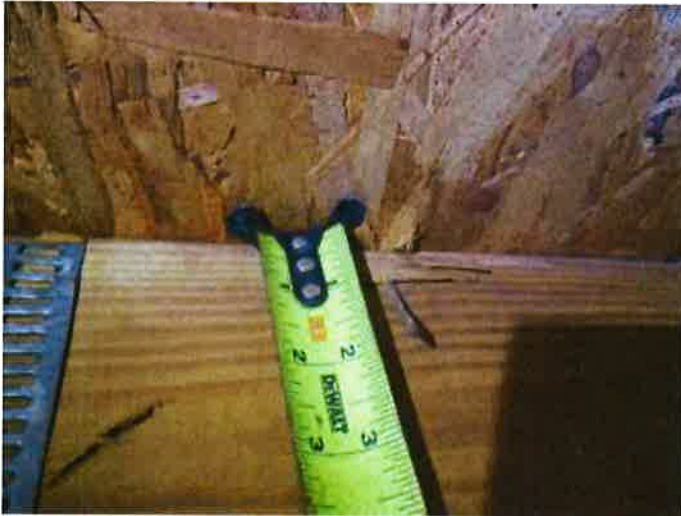
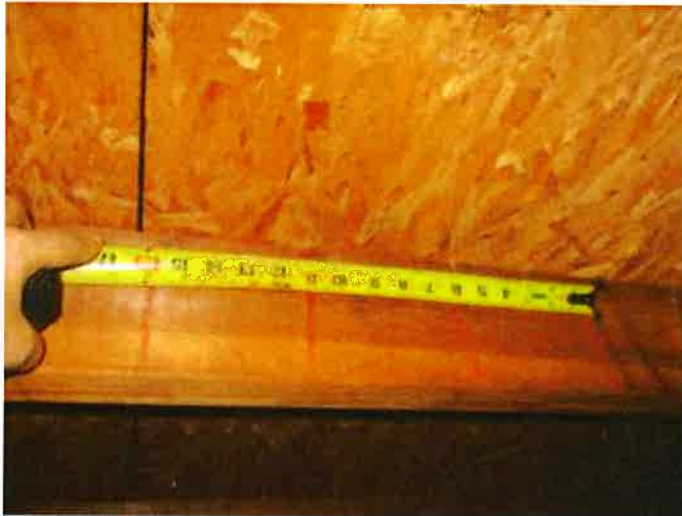
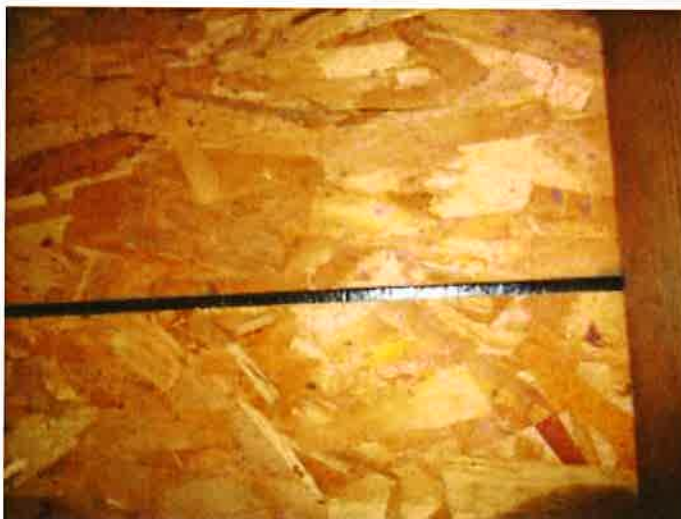
Roof Construction

6. **SWR:** **Yes**
Comments: SWR was verified at time of inspection. The Secondary Water Resistance verified is a self-adhering peel and stick.
