COMMERCIAL WINDSTORM MITIGATION REPORT (OIR-B1-1802)

Sun Ketch I Condominium Association, Inc.

207-211 Orion Ln

FPAT File# MUD1914038

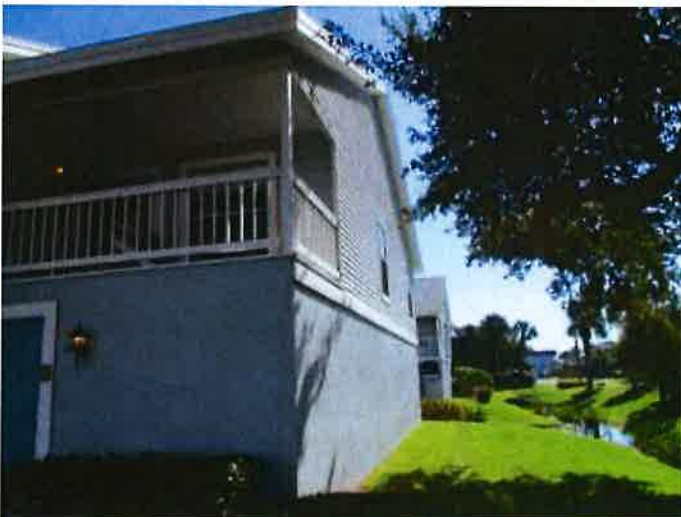
Exterior Elevation

5. **Roof Geometry:** **Other Roof**
Comments: Inspection verified a gable roof shape.

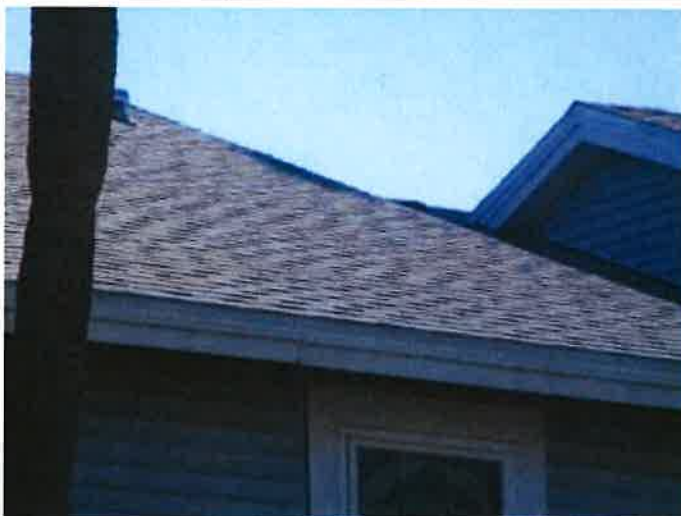
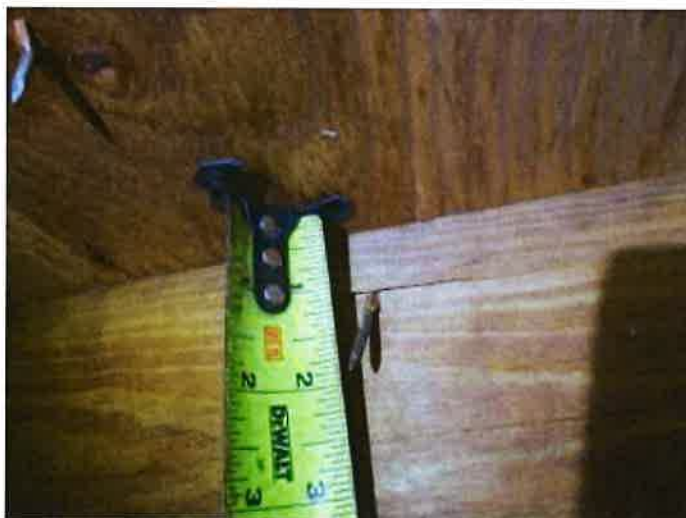
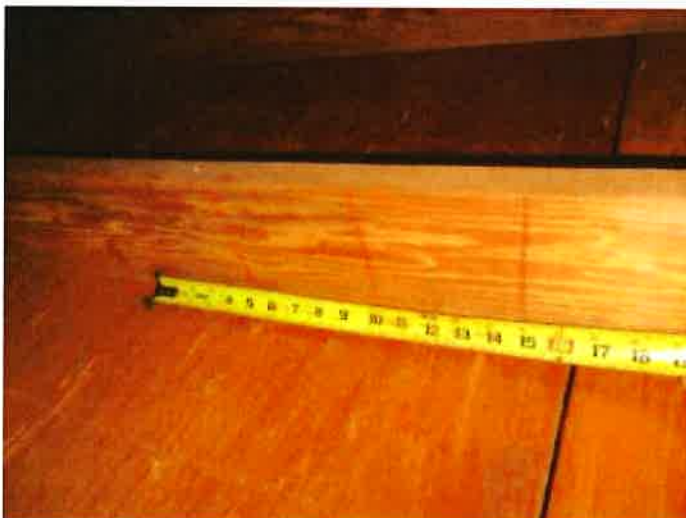
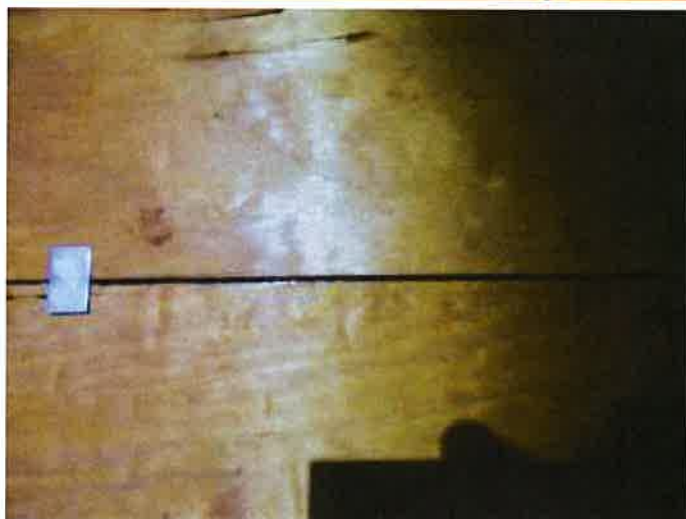
Roof Construction

3. **Roof Deck Attachment:** **Level C**
Comments: Inspection verified 1/2" plywood and OSB roof deck attached with 8d nails at a minimum 6" on the edge & 6" in the field.

4. **Roof to Wall Attachment:** **Clips**
Comments: Inspection verified hurricane clips fastened with a minimum of three nails.

6. **SWR:** **Yes**
Comments: SWR was verified at time of inspection. The Secondary Water Resistance verified is a self-adhering peel and stick.

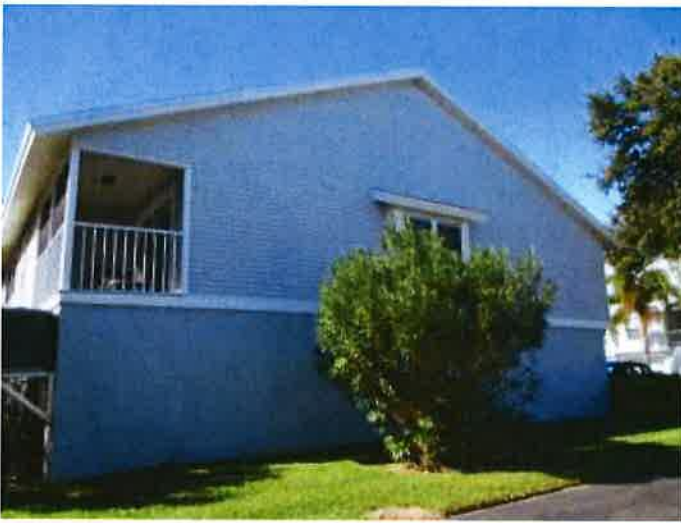
Exterior Elevation

5. **Roof Geometry:** **Other Roof**
Comments: Inspection verified a gable roof shape.

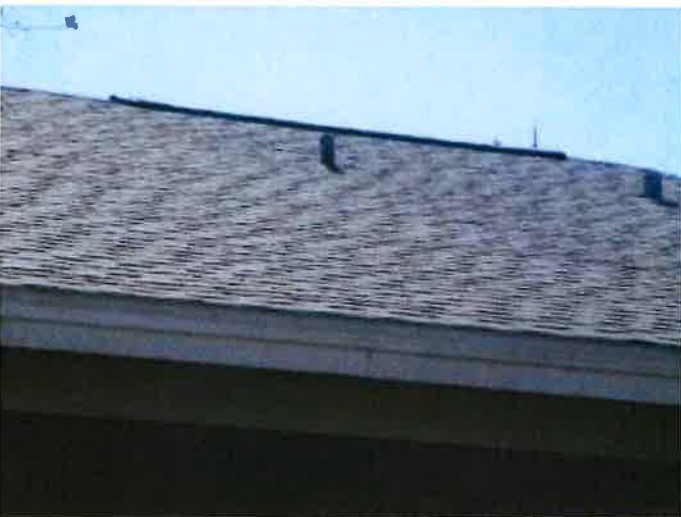
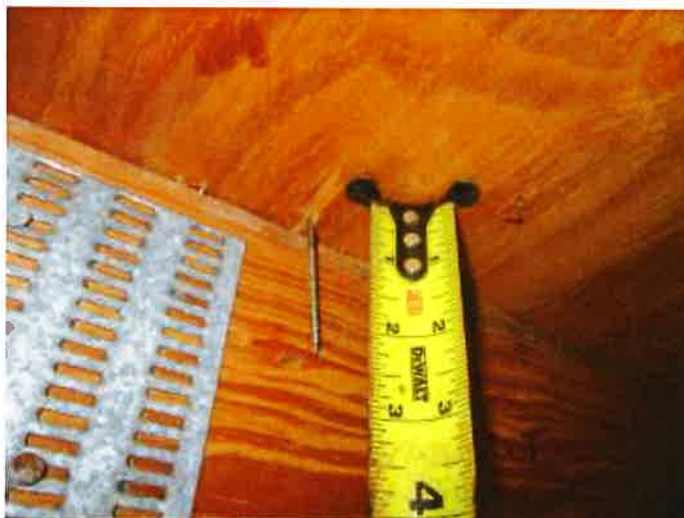
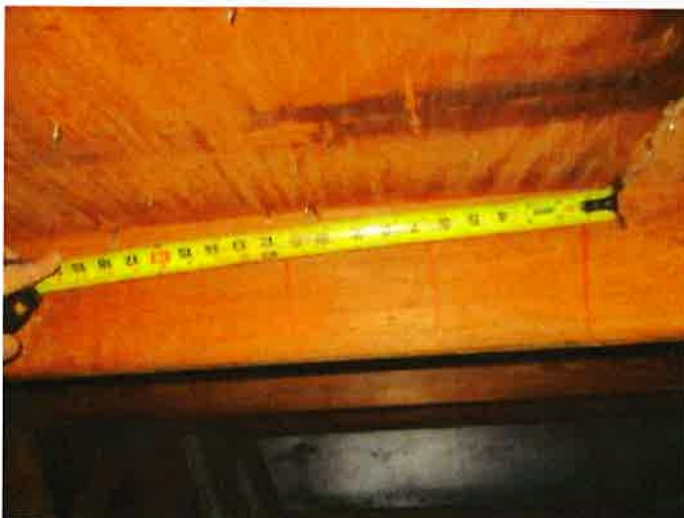
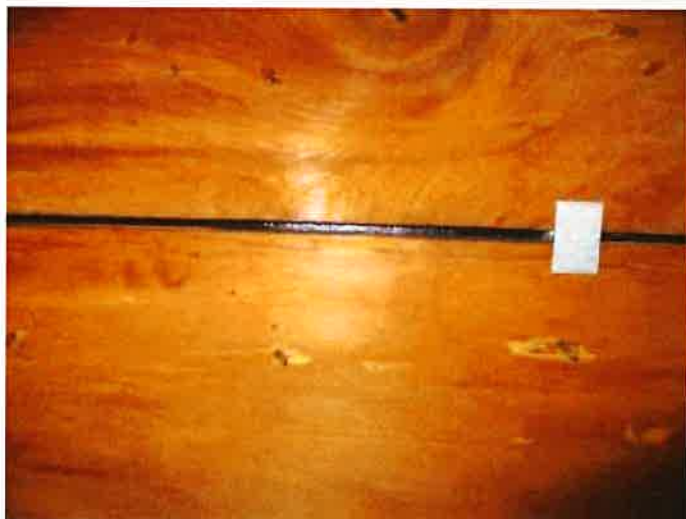
Roof Construction

3. **Roof Deck Attachment:** **Level C**
Comments: Inspection verified 1/2" plywood and OSB roof deck attached with 8d nails at a minimum 6" on the edge & 6" in the field.

4. **Roof to Wall Attachment:** **Clips**
Comments: Inspection verified hurricane clips fastened with a minimum of three nails.

6. **SWR:** **Yes**
Comments: SWR was verified at time of inspection. The Secondary Water Resistance verified is a self-adhering peel and stick.

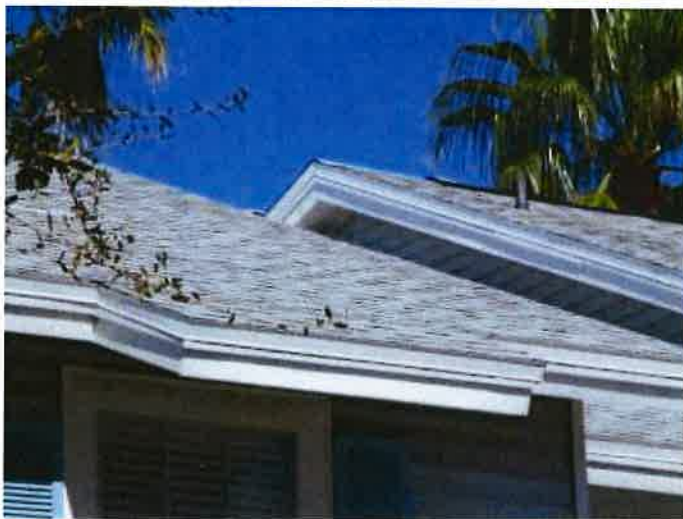
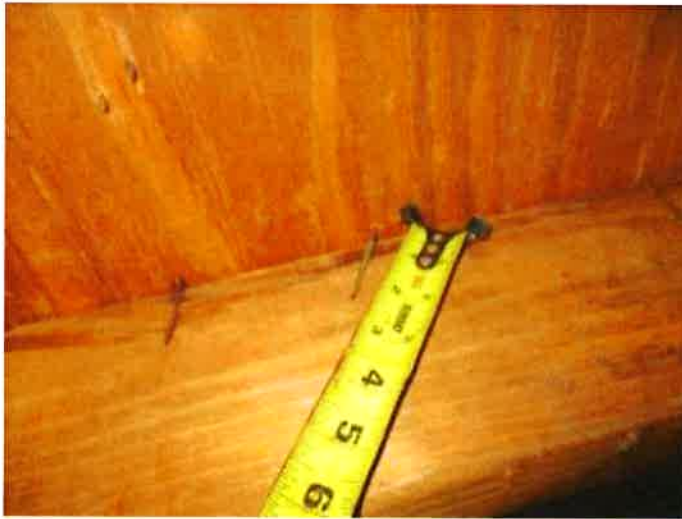
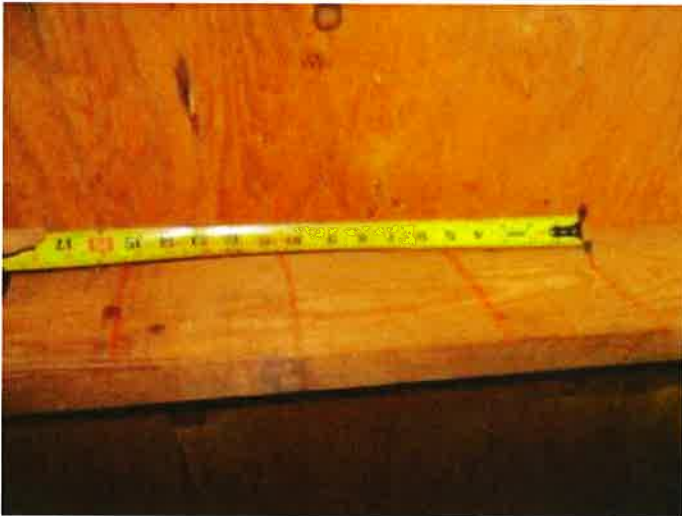
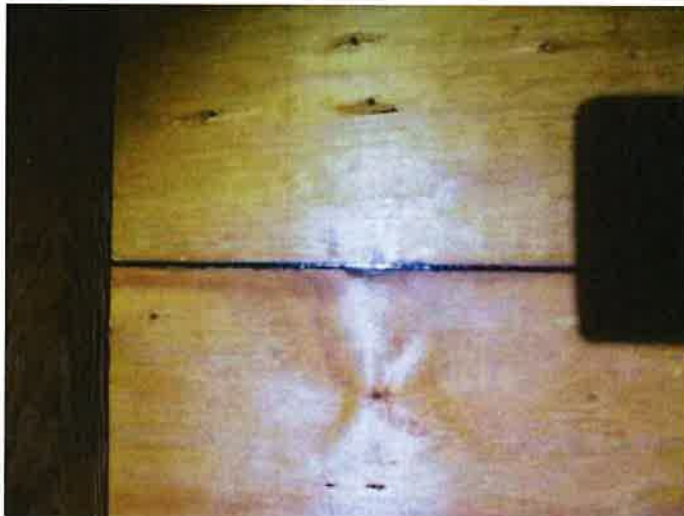
Roof Construction

6. **SWR:** **Yes**
Comments: SWR was verified at time of inspection. The Secondary Water Resistance verified is a self-adhering peel and stick.
