COMMERCIAL WINDSTORM MITIGATION REPORT (OIR-B1-1802)

Sun Ketch I Condominium Association, Inc.

234-240 Sun Ketch Ct

FPAT File# MUD1914038

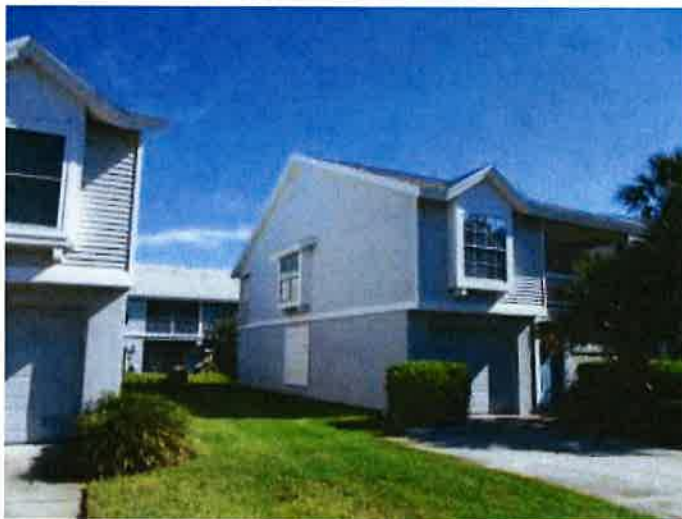
Exterior Elevation

5. **Roof Geometry:** **Other Roof**
Comments: Inspection verified a gable roof shape.

7. **Opening Protection:** **None or Some Glazed Openings**
Comments: Inspection verified some impact rated opening protection. Not all glazed openings were protected with impact resistant coverings.

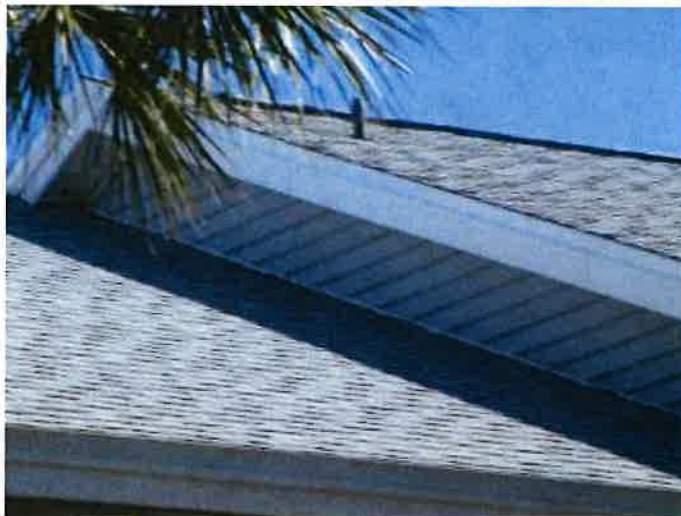
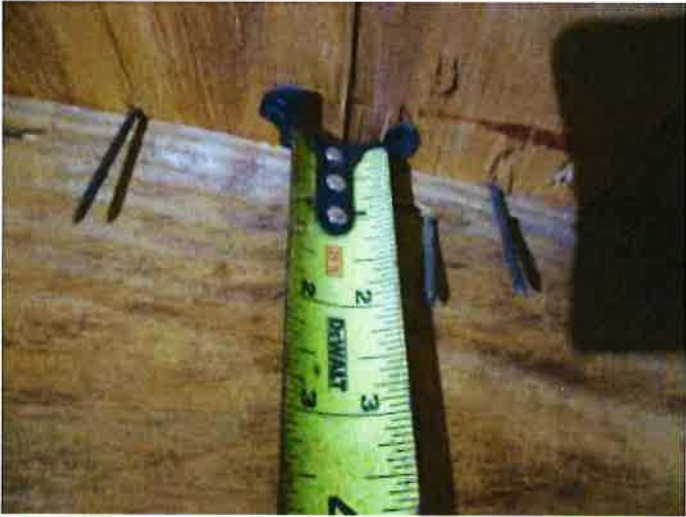
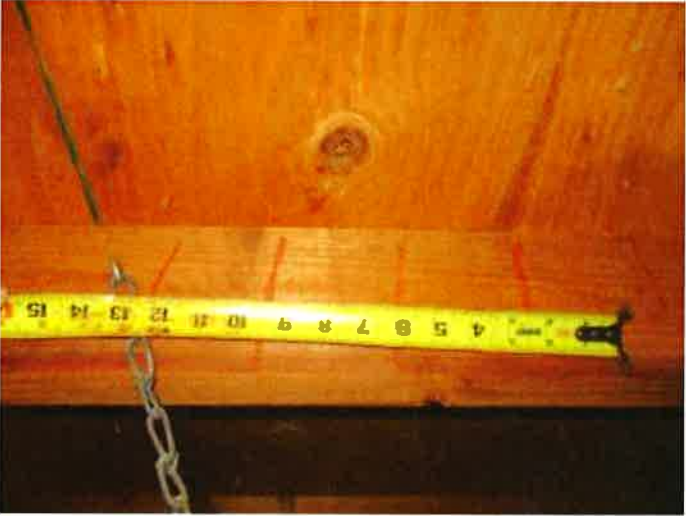
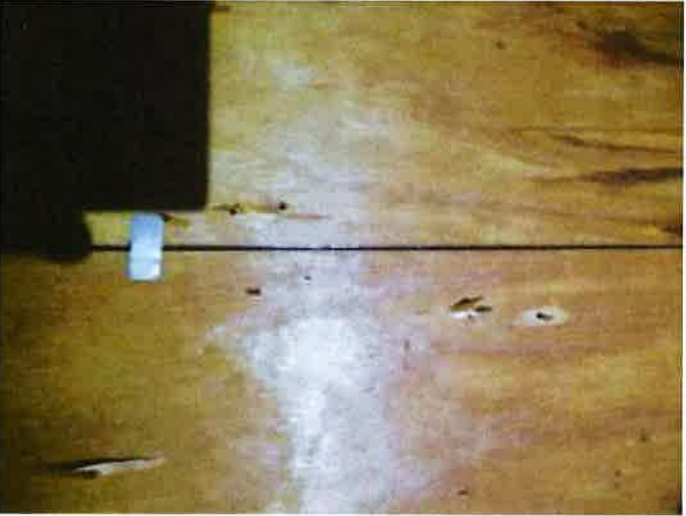
Roof Construction

3. **Roof Deck Attachment:** **Level C**
Comments: Inspection verified 1/2" plywood and OSB roof deck attached with 8d nails at a minimum 6" on the edge & 6" in the field.

4. **Roof to Wall Attachment:** **Clips**
Comments: Inspection verified hurricane clips fastened with a minimum of three nails.

6. **SWR:** **Yes**
Comments: SWR was verified at time of inspection. The Secondary Water Resistance verified is a self-adhering peel and stick.

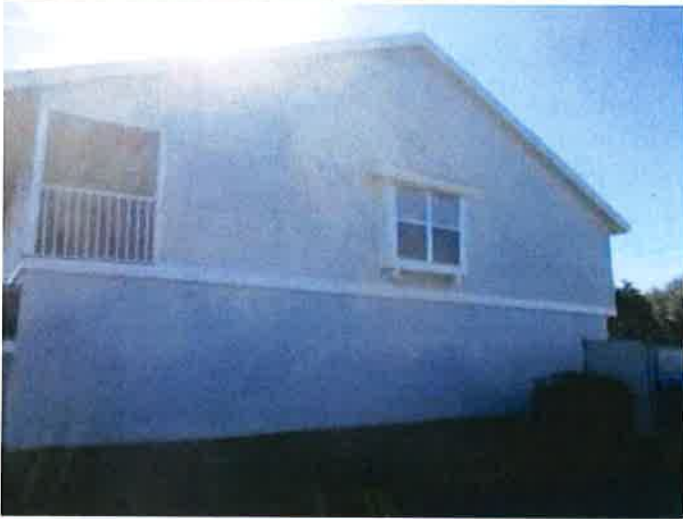
Exterior Elevation

5. **Roof Geometry:** **Other Roof**
Comments: Inspection verified a gable roof shape.

7. **Opening Protection:** **None or Some Glazed Openings**
Comments: Inspection verified some impact rated opening protection. Not all glazed openings were protected with impact resistant coverings.

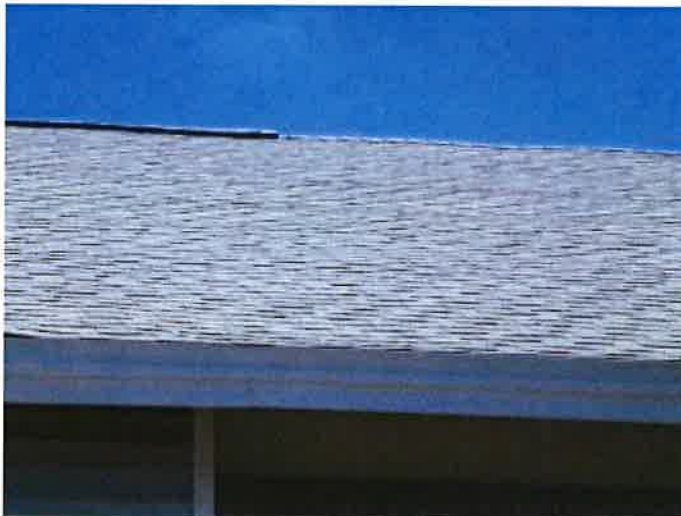
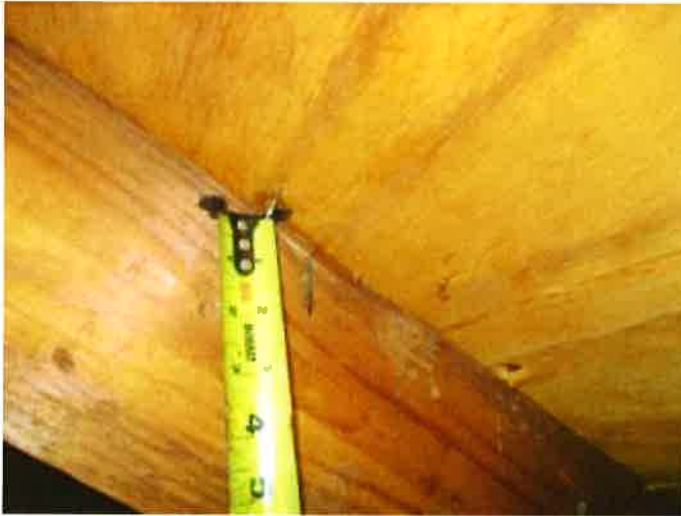
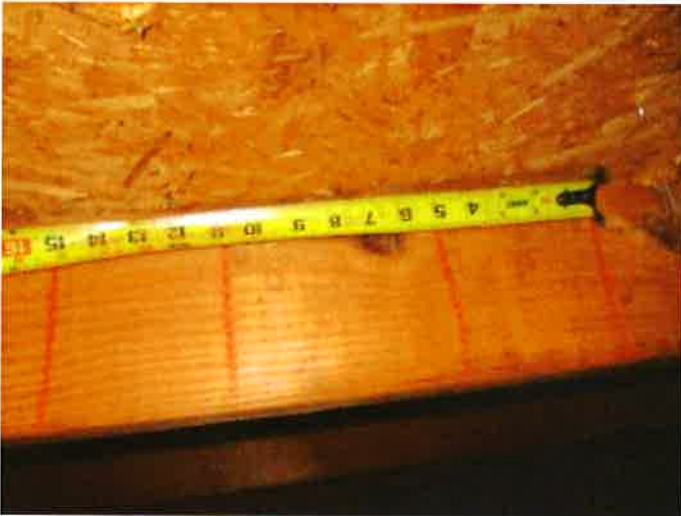
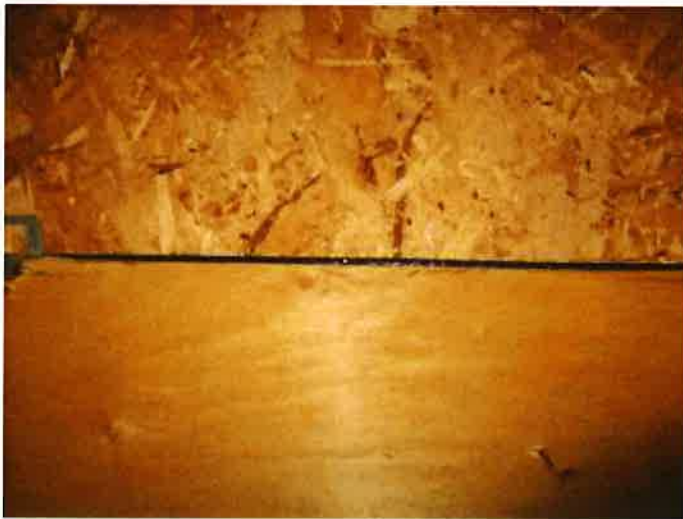
Roof Construction

3. **Roof Deck Attachment:** **Level C**
Comments: Inspection verified 1/2" plywood and OSB roof deck attached with 8d nails at a minimum 6" on the edge & 6" in the field.

4. **Roof to Wall Attachment:** **Clips**
Comments: Inspection verified hurricane clips fastened with a minimum of three nails.

6. **SWR:** **Yes**
Comments: SWR was verified at time of inspection. The Secondary Water Resistance verified is a self-adhering peel and stick.
