COMMERCIAL WINDSTORM MITIGATION REPORT (OIR-B1-1802)

Sun Ketch I Condominium Association, Inc.

250-254 Sea Mist Dr

FPAT File# MUD1914038

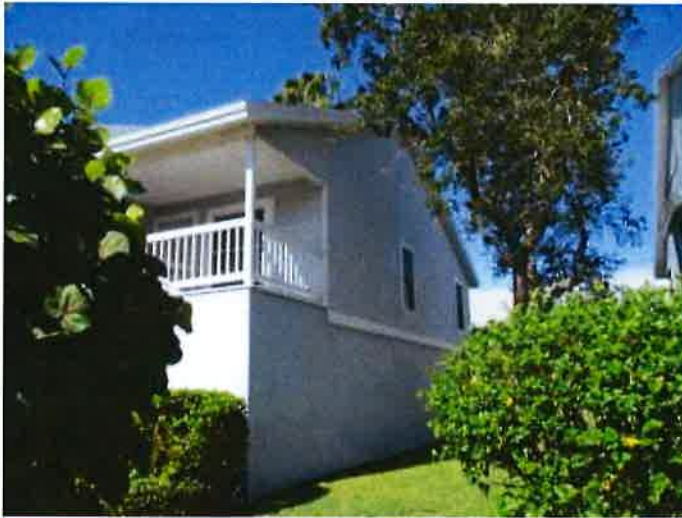
Exterior Elevation

5. **Roof Geometry:** **Other Roof**
Comments: Inspection verified a gable roof shape.

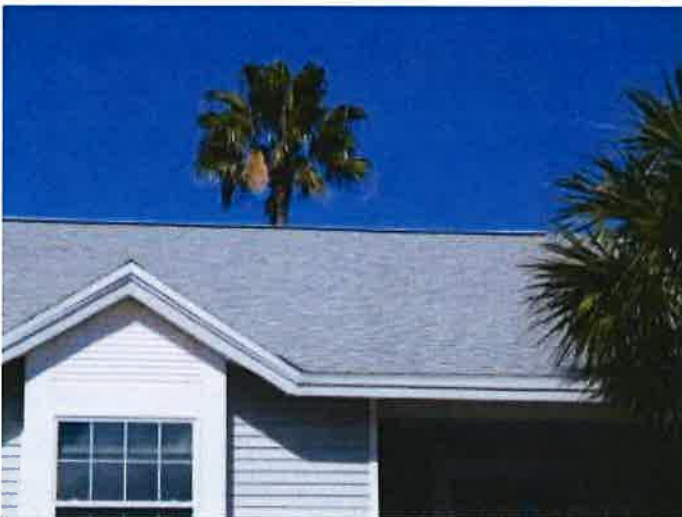
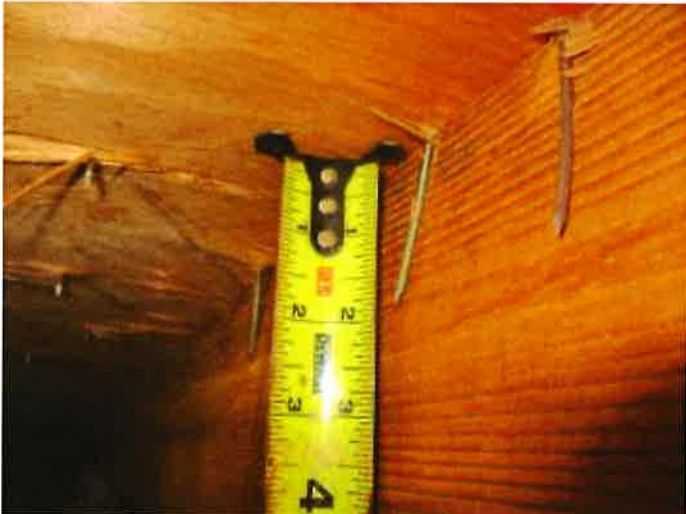
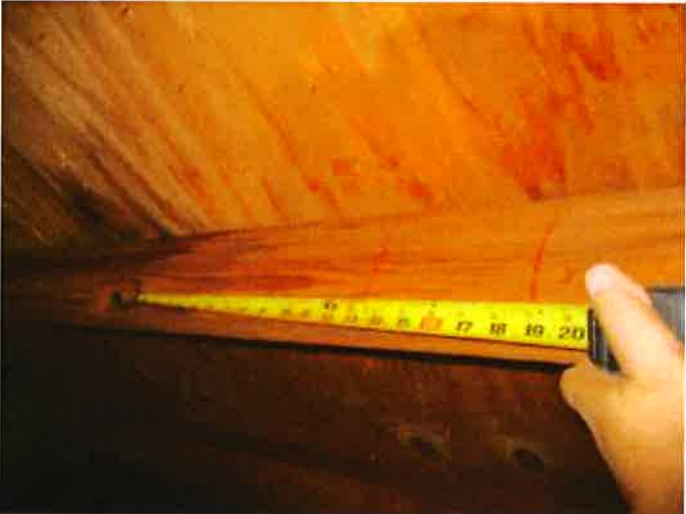
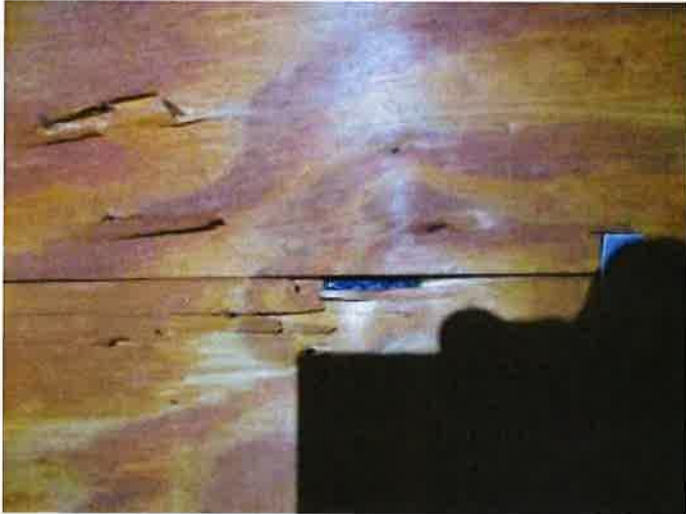
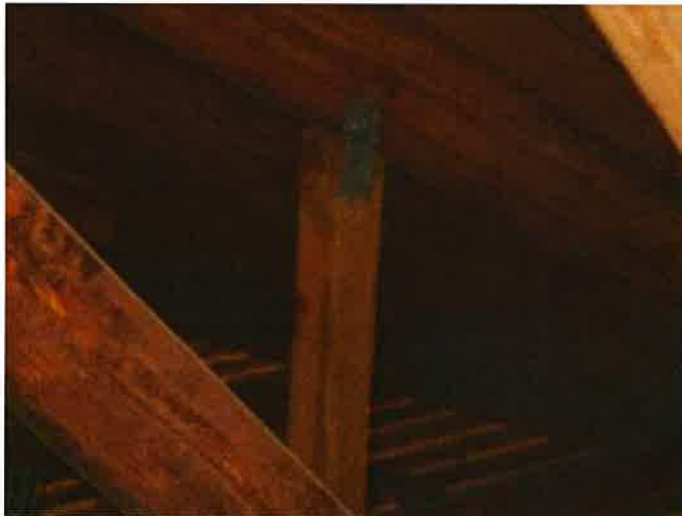
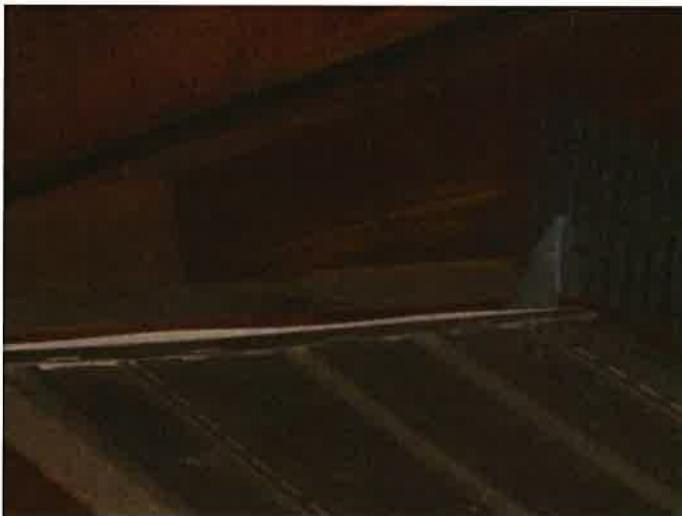
Roof Construction

3. **Roof Deck Attachment:** **Level C**
Comments: Inspection verified 1/2" plywood and OSB roof deck attached with 8d nails at a minimum 6" on the edge & 6" in the field.

4. **Roof to Wall Attachment:** **Clips**
Comments: Inspection verified hurricane clips fastened with a minimum of three nails.

6. **SWR:** **Yes**
Comments: SWR was verified at time of inspection. The Secondary Water Resistance verified is a self-adhering peel and stick.

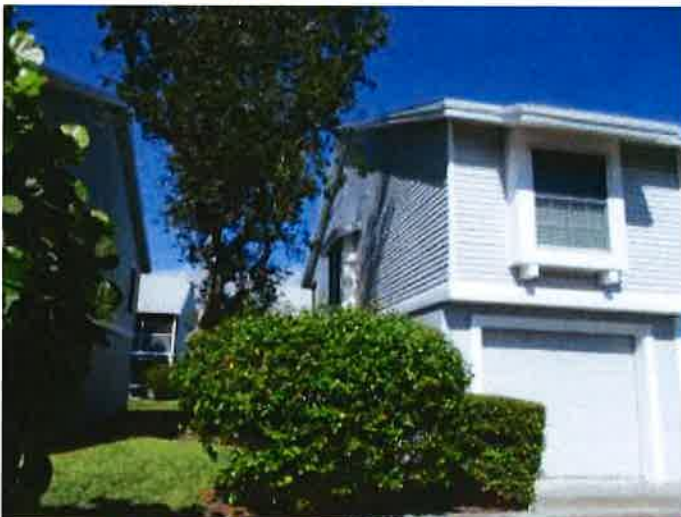
Exterior Elevation

5. **Roof Geometry:** **Other Roof**
Comments: Inspection verified a gable roof shape.

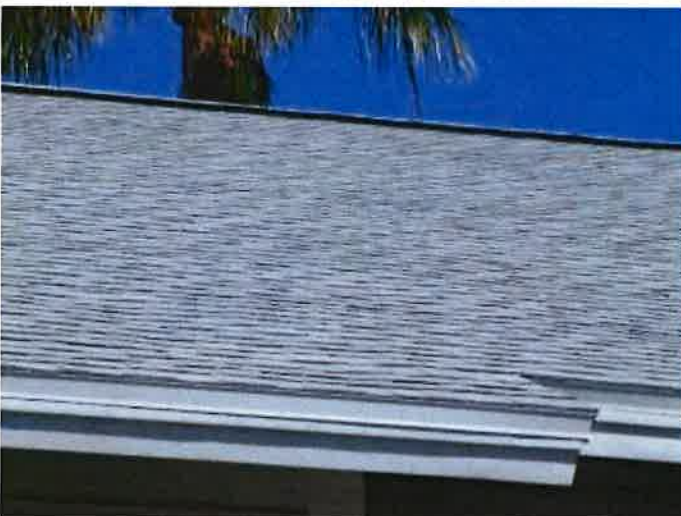
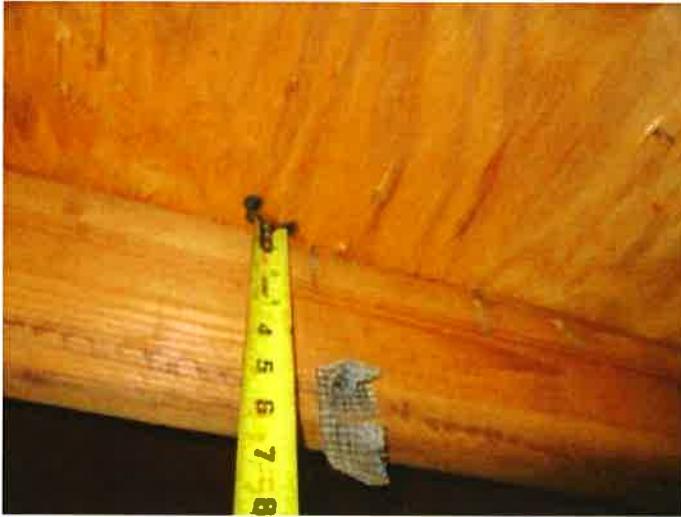
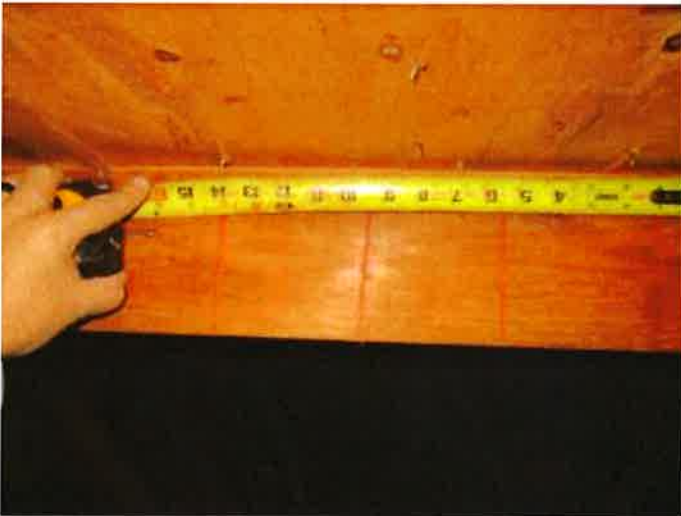
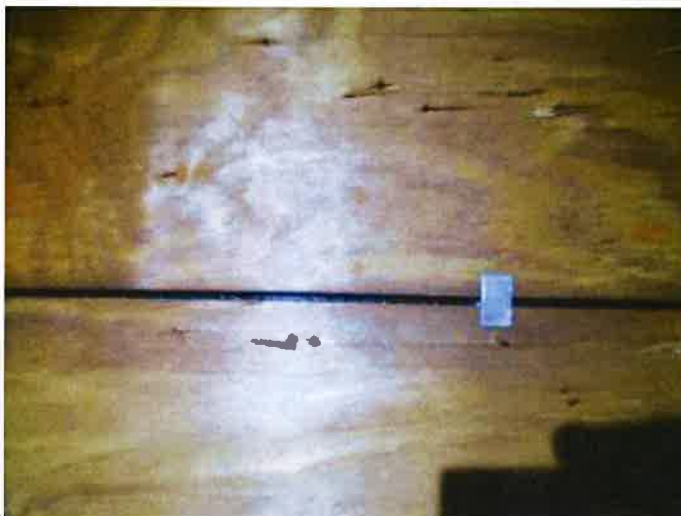
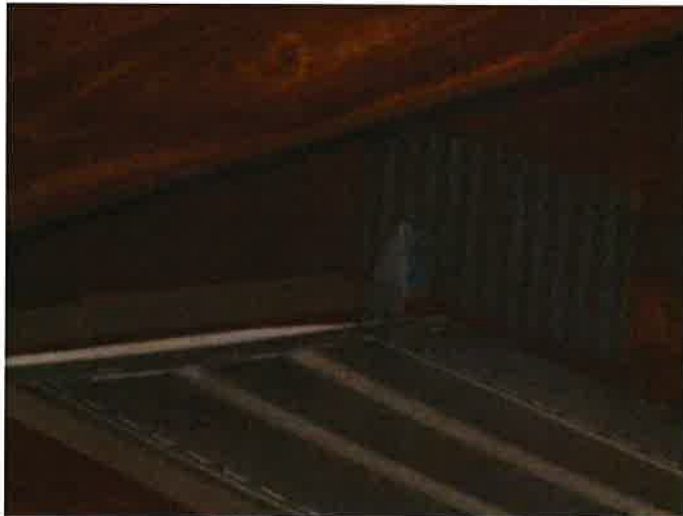
Roof Construction

3. **Roof Deck Attachment:** **Level C**
Comments: Inspection verified 1/2" plywood and OSB roof deck attached with 8d nails at a minimum 6" on the edge & 6" in the field.

4. **Roof to Wall Attachment:** **Clips**
Comments: Inspection verified hurricane clips fastened with a minimum of three nails.

6. **SWR:** **Yes**
Comments: SWR was verified at time of inspection. The Secondary Water Resistance verified is a self-adhering peel and stick.
