# Sun Ketch 1 Condo Association Inc Bldg 6

## Wind Mitigation Inspection Report

Date/Time: 6/2/2025 8-12  
First Name: Sun Ketch 1 Condo  
Last Name: Association Inc Bldg 6  
Contact Number:  
Contact Number:  
E-mail:  
Address: 234-240 Sun Ketch Ct  
City: Treasure Island  
State: FL  
Zip: 33706  
County: Pinellas  
Advertiser: Previous Customer  
Referred By:

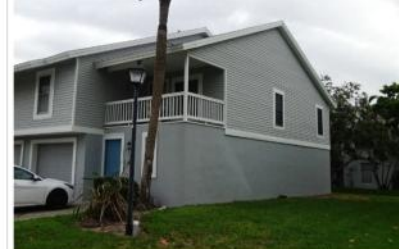
Geometry Picture

Roof Geometry: Non-Hip

Gable end walls and/or non-hip features are greater than 10% of total perimeter

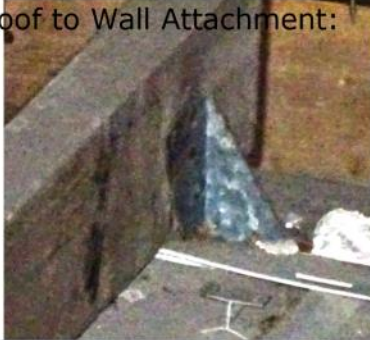
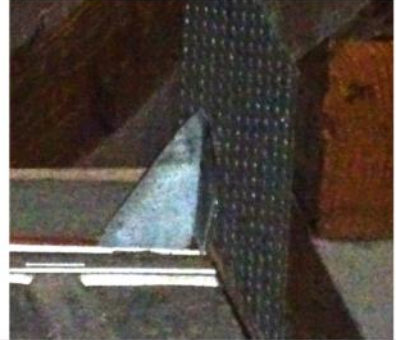
Roof to Wall Attachment:

- ☒ B. Clips
  - ☒ Metal connectors that do not wrap over the top of the truss/rafter, **or**
  - ☒ Metal connectors with a minimum of 1 strap that wraps over the top of the truss/rafter and does not meet the nail position requirements of C or D, but is secured with a minimum of 3 nails.

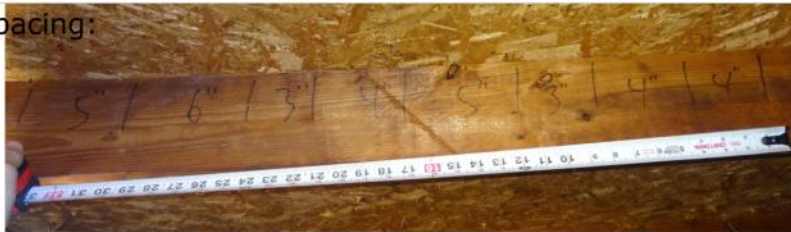
Nail Spacing:

- ☒ C. Plywood/OSB roof sheathing with a minimum thickness of 7/16" inch attached to the roof truss/rafter (spaced a maximum of 24" inches o.c.) by 8d common nails spaced a maximum of 6" inches in the field. -OR- Dimensional lumber/Tongue Groove decking with a minimum of 2 nails per board (or 1 nail per board if each board is equal to or less than 6 inches in width). -OR- Any system of screws, nails, adhesives, other deck fastening system or truss/rafter spacing that is shown to have an equivalent
