# Sun Ketch 1 Condo Association Inc Bldg 9

## Wind Mitigation Inspection Report

By: Fair Wind Inspections Inc.

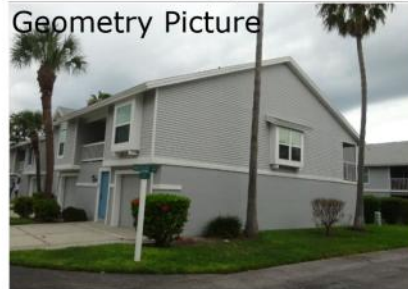
Geometry Picture

Roof Geometry: Non-Hip  
Total Non-Hip: N/A Total Perimeter: N/A  
Less Than 2:12: N/A Total Area: N/A

Gable end walls and/or non-hip features are greater than 10% of total perimeter

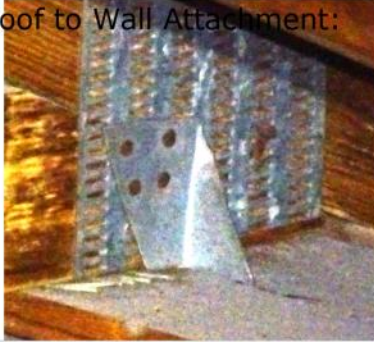
Roof to Wall Attachment:

- ☒ B. Clips
  - ☒ Metal connectors that do not wrap over the top of the truss/rafter, **or**
  - ☒ Metal connectors with a minimum of 1 strap that wraps over the top of the truss/rafter and does not meet the nail position requirements of C or D, but is secured with a minimum of 3 nails.

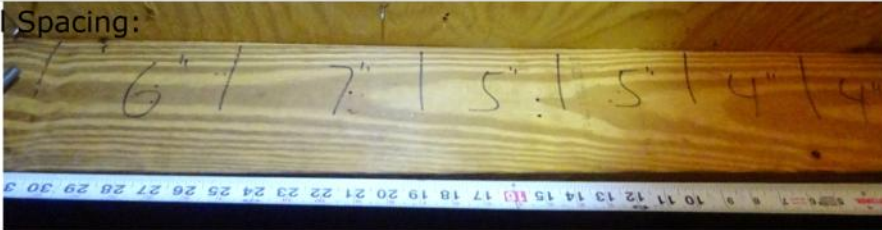
Nail Spacing:

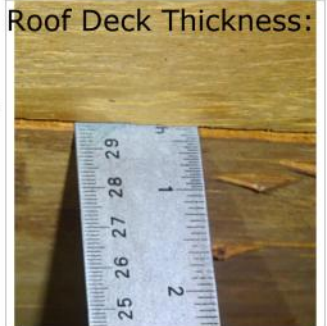
Roof Deck Thickness:

- ☒ C. Plywood/OSB roof sheathing with a minimum thickness of 7/16" inch attached to the roof truss/rafter (spaced a maximum of 24" inches o.c.) by 8d common nails spaced a maximum of 6" inches in the field. -OR- Dimensional lumber/Tongue Groove decking with a minimum of 2 nails per board (or 1 nail per board if each board is equal to or less than 6 inches in width). -OR- Any system of screws, nails, adhesives, other deck fastening system or truss/rafter spacing that is shown to have an equivalent
